**Application**  
Traffic Responsive  
Delay Time, Queue Warning

**Location**  
Hastings, MN

**Technology**  
4 PCMS's  
1 Delay Time Displays  
6 Traffic Sensors  
2 Cameras

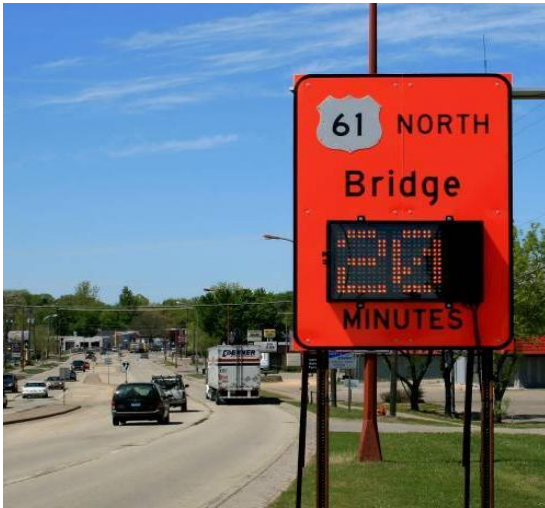
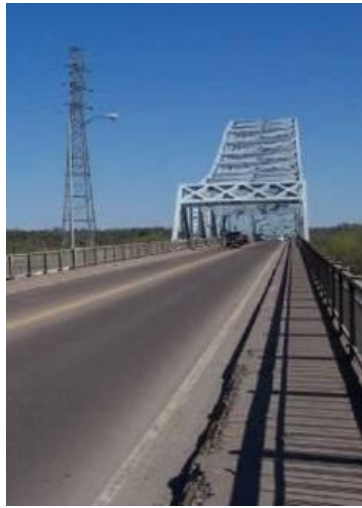
Together with MnDOT, JamLogic designed and deployed an automated work zone that conveyed travel times, suggested alternate routes during major congestion, and provided stopped traffic warnings to the traffic approaching the queued vehicles. Prepare to Stop static signs with flashers (shown below) were installed along the long southbound approach to the bridge to reduce the chance of rear end crashes. A combination of queue length and delay time determined automatic activation for Use Alternate Route messaging.
